## Memorandum

RE Golden Gate Theater, 909 S. Atlantic Boulevard, Los Angeles CA  
*Secretary's Standards* Conformance Review (Revised Version)

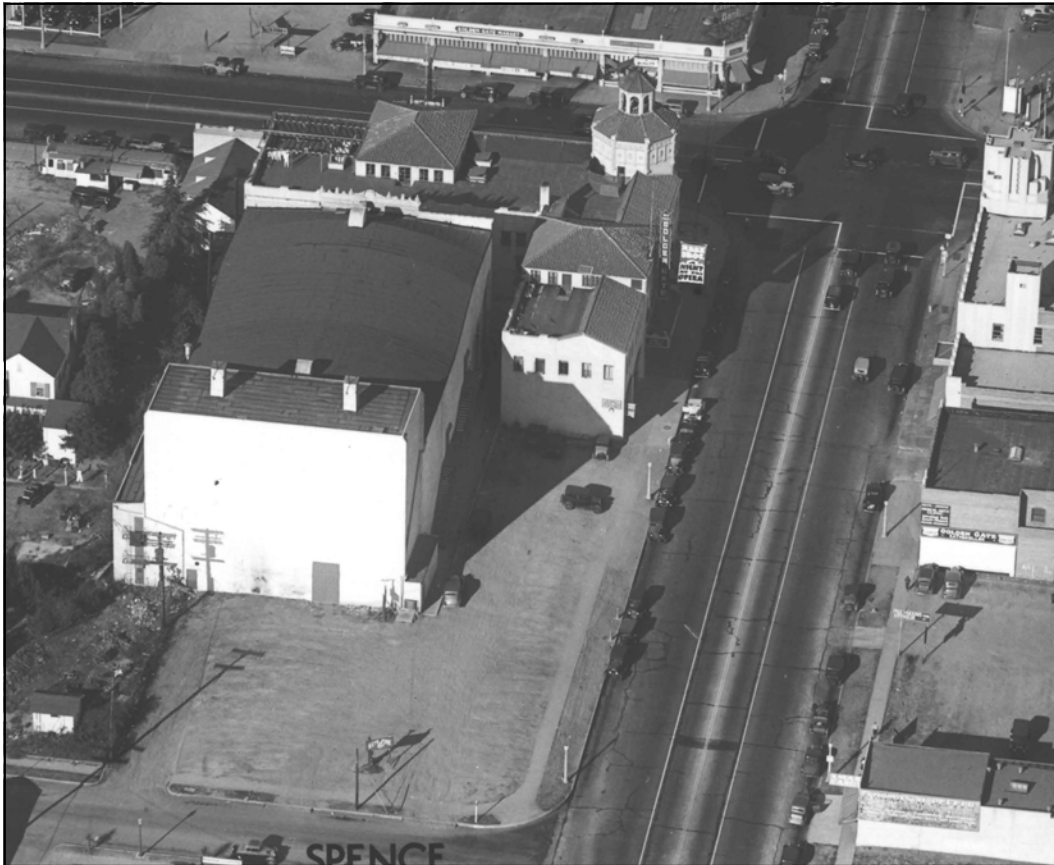
- Selection of off-white paint color for exterior wall surfaces was made based on tenant needs and recommendations by Chattel for consistency with historic photos indicating exterior surfaces were historically painted off-white (Appendix A, fig 1).

Figure 1: Golden Gate Theater and Vega Building (demolished), aerial view northwest, 1935 (Spence Air Photo Archives, University of California, Los Angeles)
